The Da Nang Glider
Larry Westin - March 16, 2001
Updated Rev. B - 08/02/08

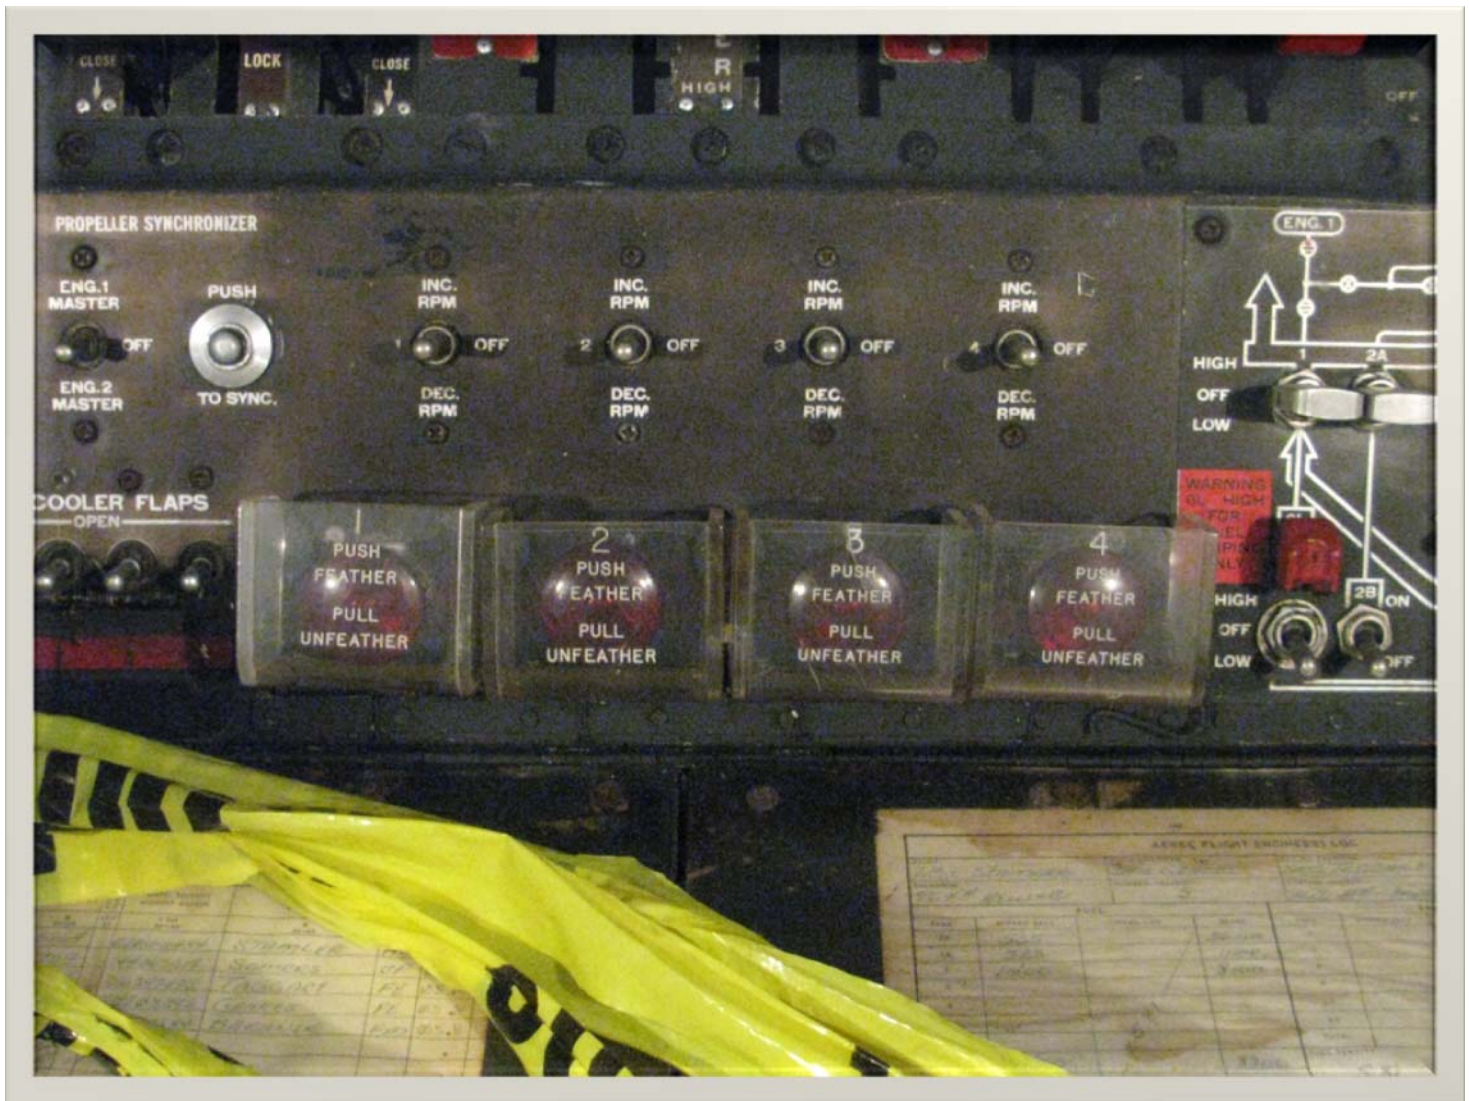
As Col. January entered the flight deck the first visible

indication of the problem was that all four feather switch/indicators were bright red.
