SECTION VII—SYSTEMS OPERATION

ENGINE OPERATION.

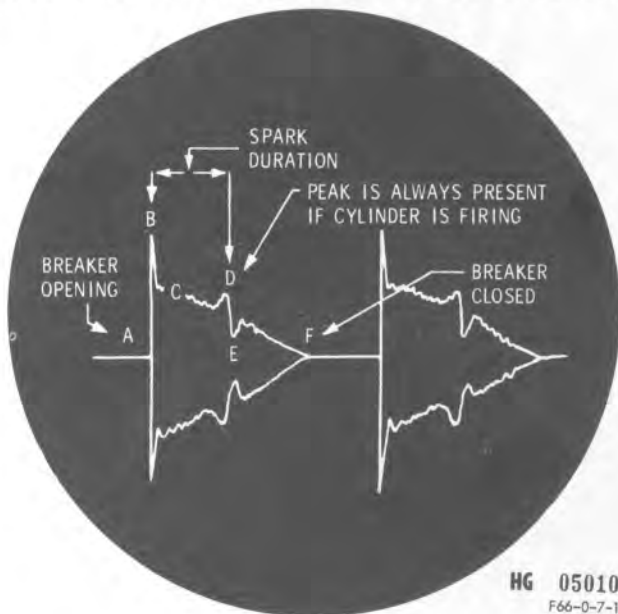
NORMAL IGNITION PATTERN EXPLANATION

Figure 7-1 shows a normal ignition analyzer pattern. The letter headings in the discussion following correspond to the letter positions on figure 7-1.

D. Combustion Indication Hook. This portion of the pattern is associated with the combustion phenomena. The height and position of the combustion hook at D are determined by combustion mixtures and cylinder condition. A stable or stationary hook indicates good combustion characteristics.

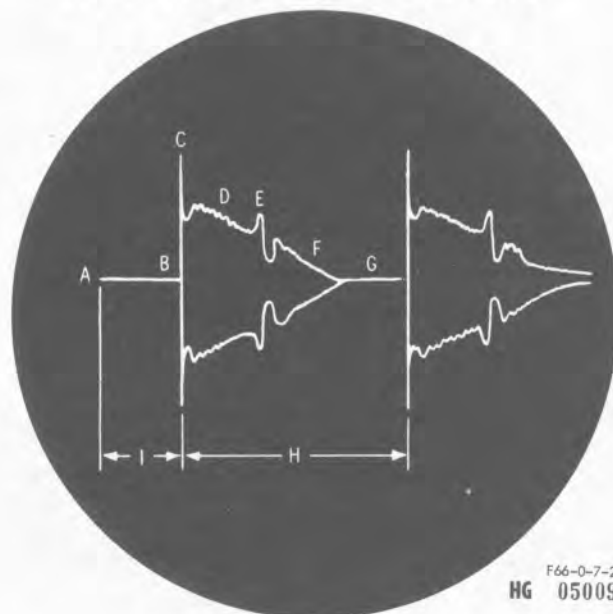
Figure 7-2

EFFECT OF IGNITION MALFUNCTION ON NORMAL PATTERN

The letter headings in the discussion following correspond to the letter positions of figure 7-2.

H. Distance Between Two Patterns. The distance between two patterns is determined by the number of crankshaft degrees between two consecutive firing impulses (cam compensation causes this to vary from cylinder to cylinder).
